Detailed
Damage
Survey
Mapping

Kaua'i: Hurricane Iniki Building Damage Mapped By Parcel

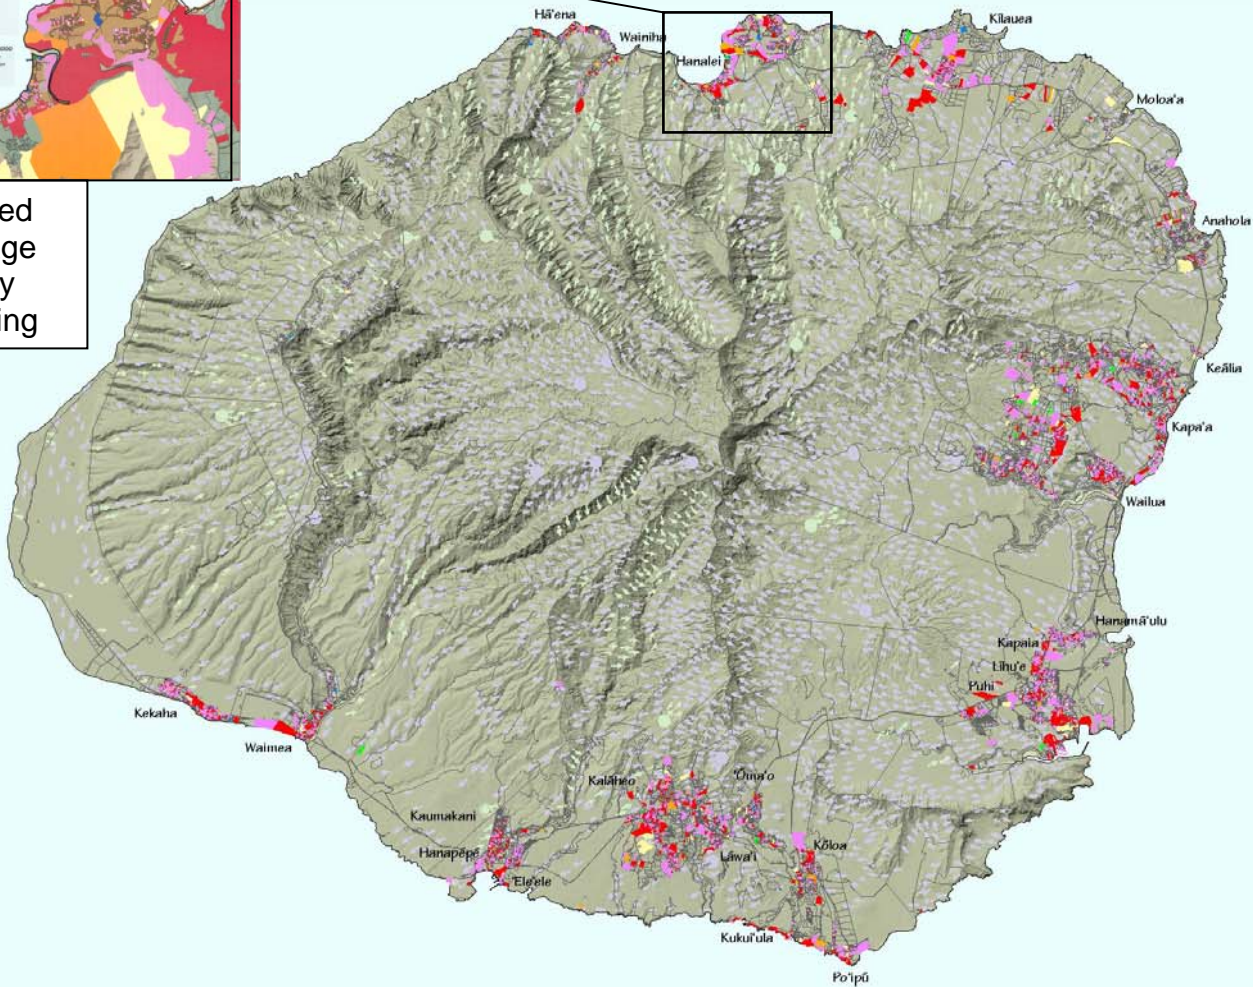
NOTE:
Total number of damaged parcels mapped: 5644
The most severe damage level is shown for each parcel.
Detailed damage maps are plotted for individual areas.
